# **Tree Management Plan**

## **the Kingston Avenue of Honour**

**Homewood Consulting Pty Ltd**  
Unit 10 / 350 Settlement Road  
Thomastown VIC 3074

**Tuesday, 1 March 2022**

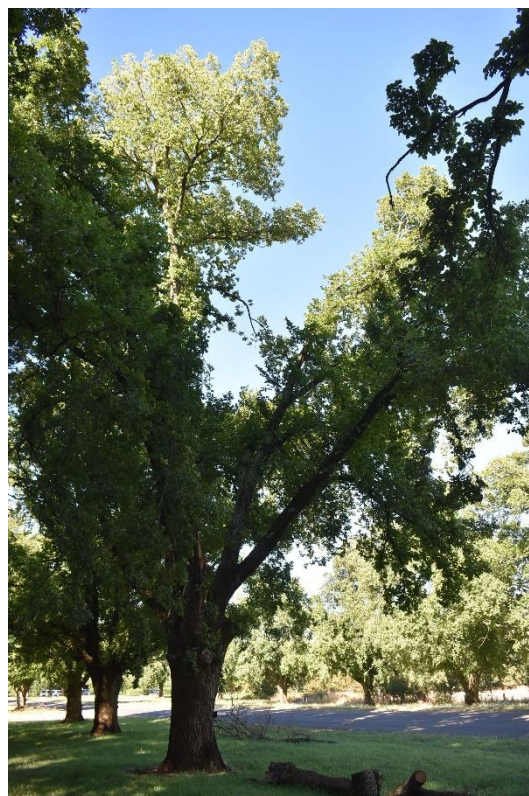
Figure 3: Poorly structured canopy following significant storm damage

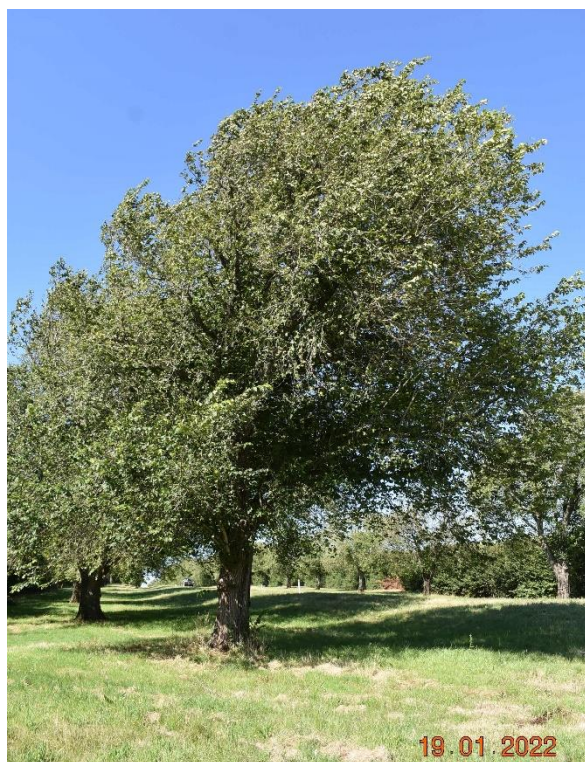
Figure 9: Tree E21 – Good health

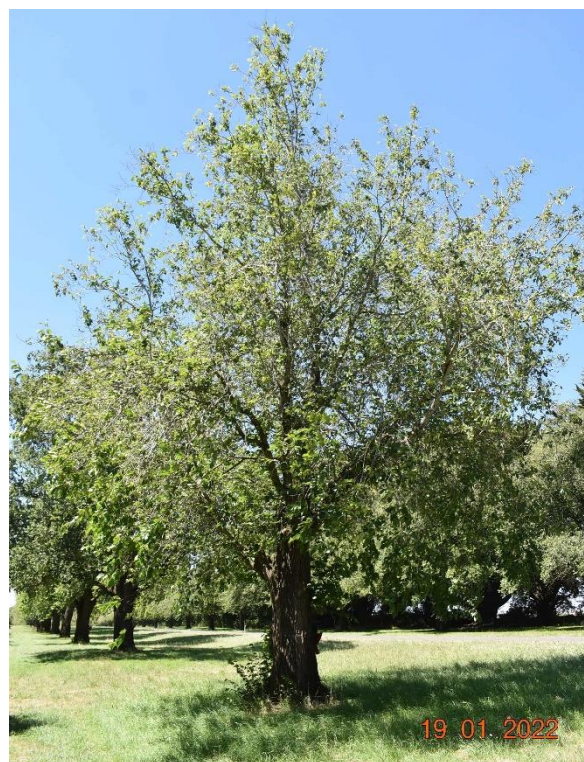
Figure 10: Tree W40 – Fair health

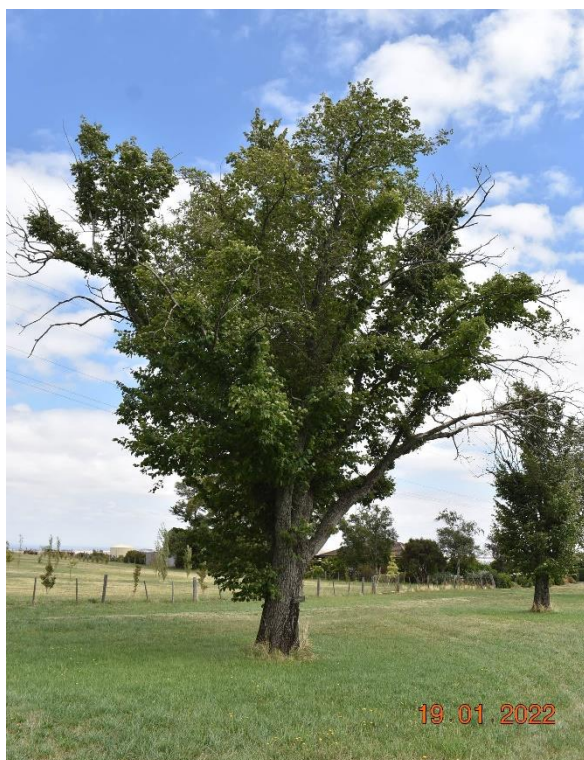
Figure 11: Tree W17 – Poor health

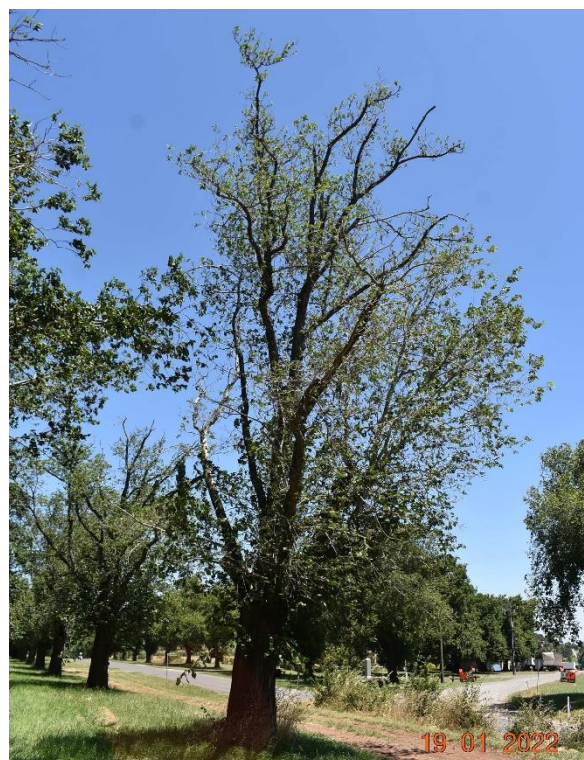
Figure 12: Tree E51 - Very Poor health

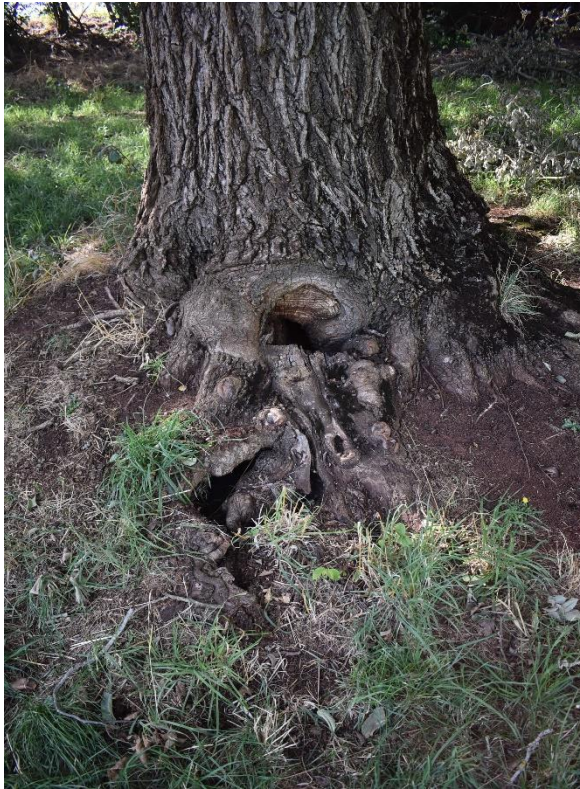
Figure 13: Tree E68 – basal trunk/ buttress root decay and cavities

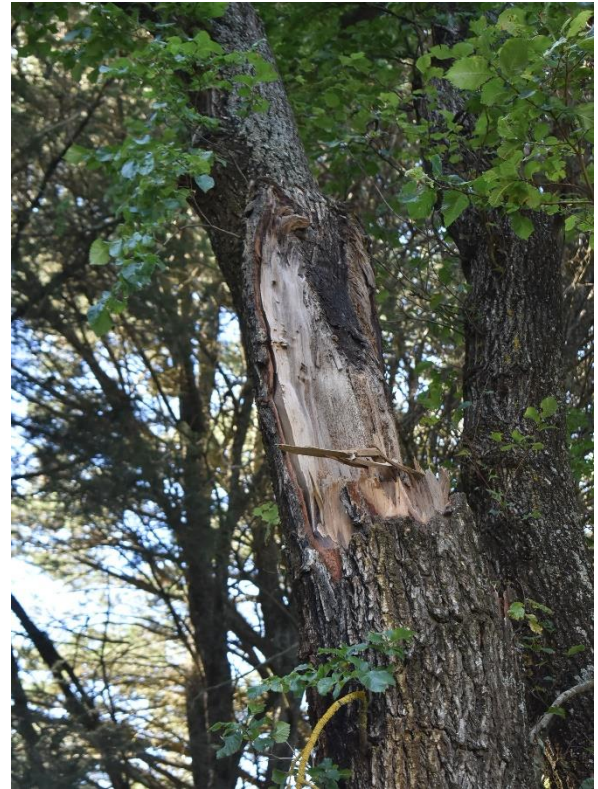
Figure 14: Tree E82 – large stem failure in canopy with evidence of included bark in union

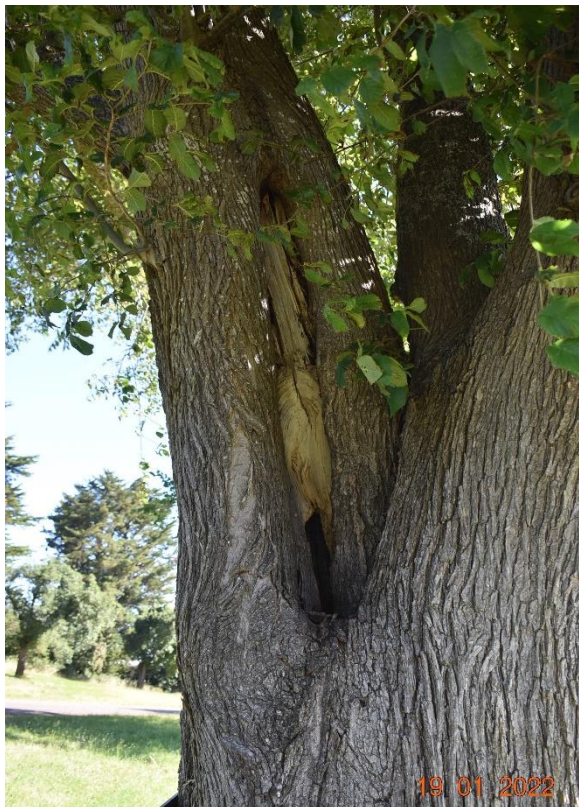
Figure 15: Tree W58 – codominant stems with included bark and internal trunk cavity

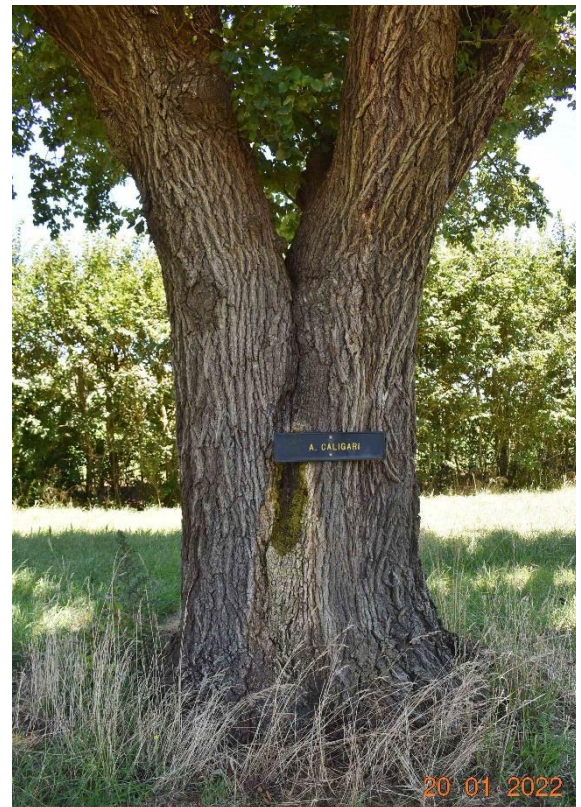
Figure 16: Tree W103 – codominant stems with signs of internal cracking down the trunk

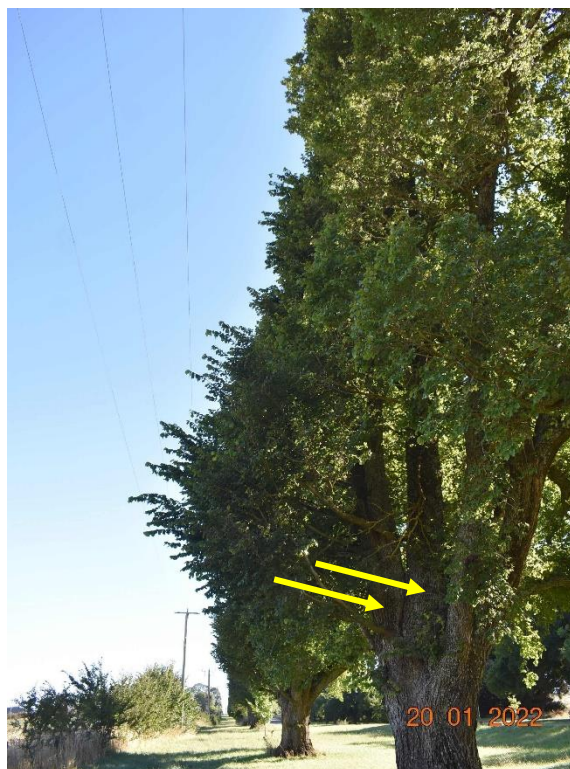
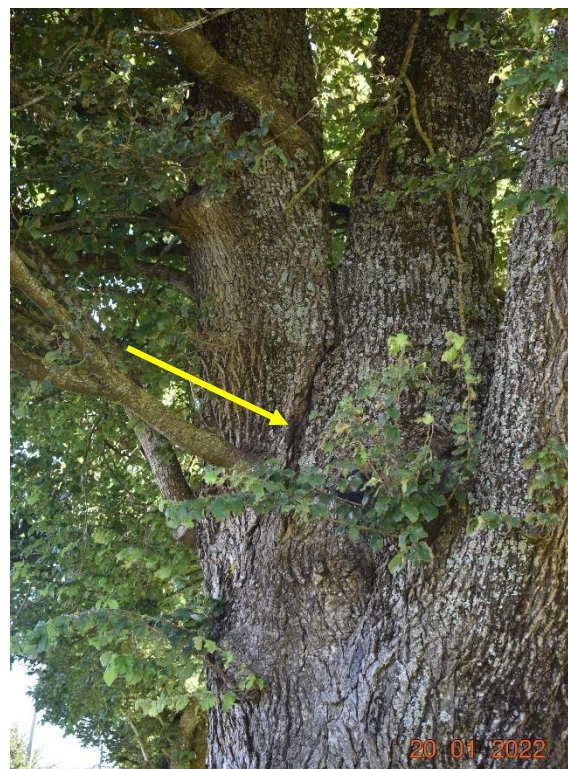
Figure 18: Tree W82 – codominant stems with deep bark inclusion adjacent to HV lines

Figure 19: Tree W82 – the poor attachment due to included bark between the stems can be seen

- One tree is recommended for Urgent priority work.
  - Tree W82 requires a cable system to be installed to reduce the risk of stem failure onto HV wires.

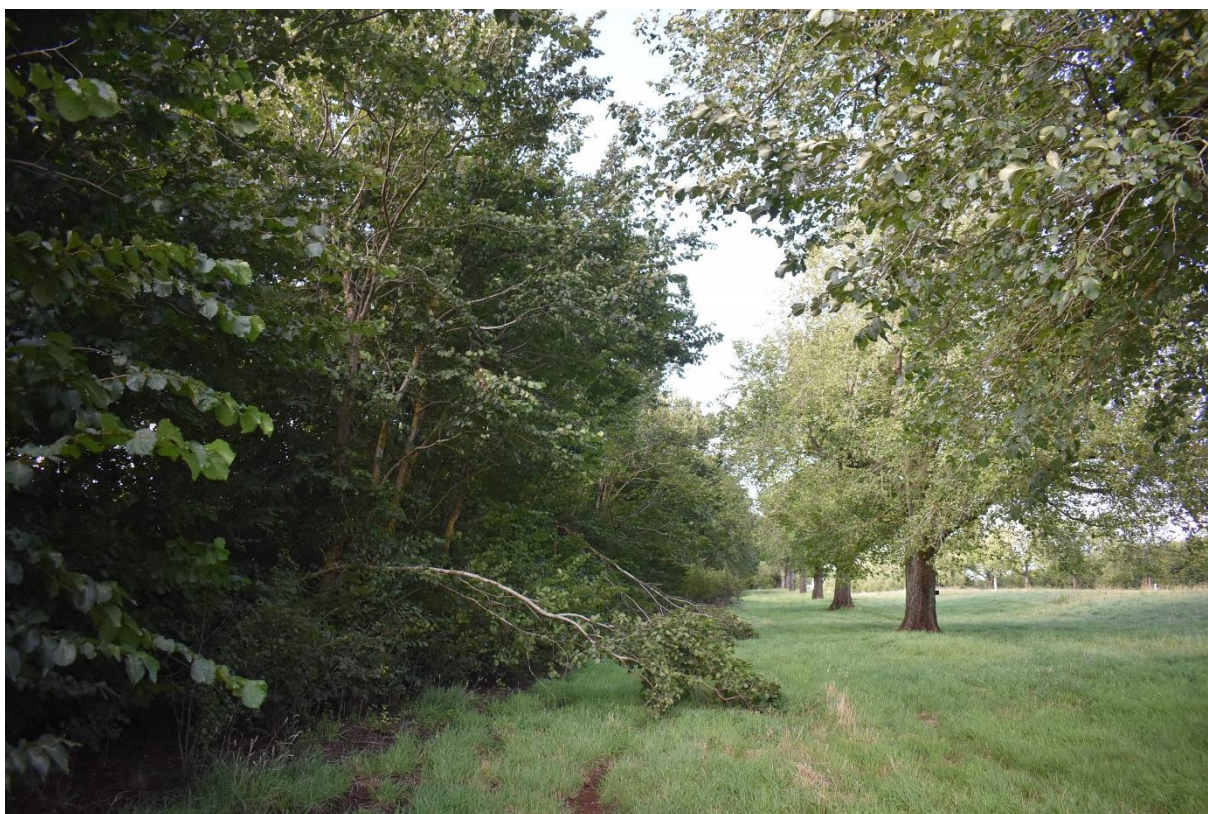
Figure 20: In some areas, suckers are as tall as the mature Avenue trees

It is recommended that areas currently free of suckers are maintained as such, and that where possible, suckers are removed adjacent to new plantings so as to reduce shading of young trees.

Extreme care is required if using herbicides for sucker control, as root grafting may have occurred (Spencer, Hawker and Lumley 1991) and poison could impact Avenue trees, leading to injury or death. Herbicide control of suckers will require a permit under the Heritage Listing for the Avenue.

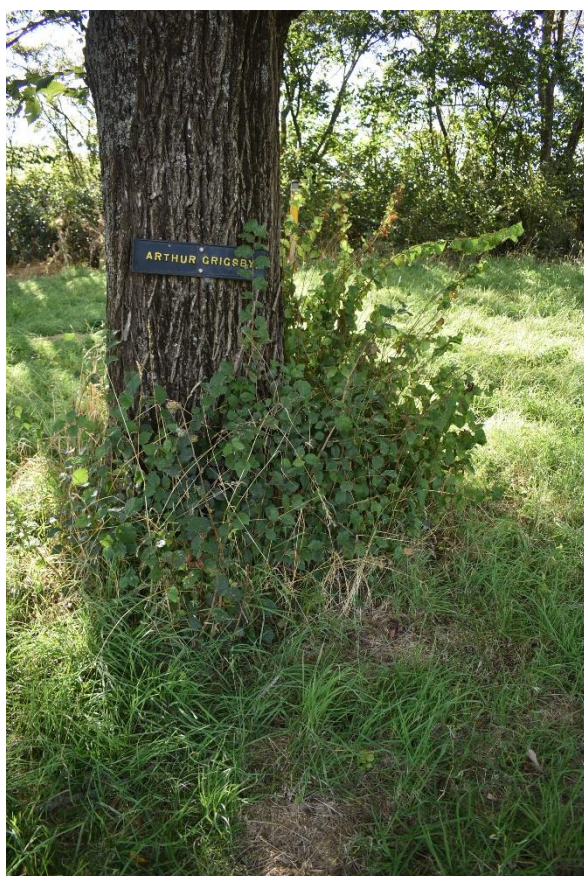
Figure 21: Grass, weed and sucker control is required around the base of trees

At a minimum, each tree should be mulched in a circle 3m from the trunk. Over time, the area of mulch should be increased, with the eventual aim of having all trees mulched to 1m beyond the drip line.

Mulch should be applied to a depth of 100-150mm. The mulch used should be anything organic that is well-composted, for example wood chips that contain a blend of leaves, bark and wood. Mulch should be applied so that it is not piled up against the trunk and the root crown is exposed.

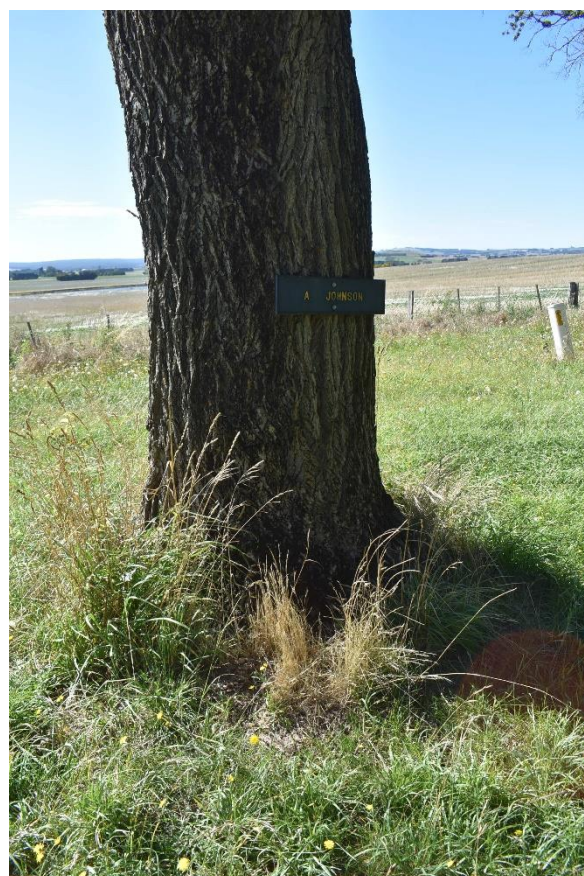
Figure 22: Mowing or brush cutting next to the trunk often leads to mechanical damage

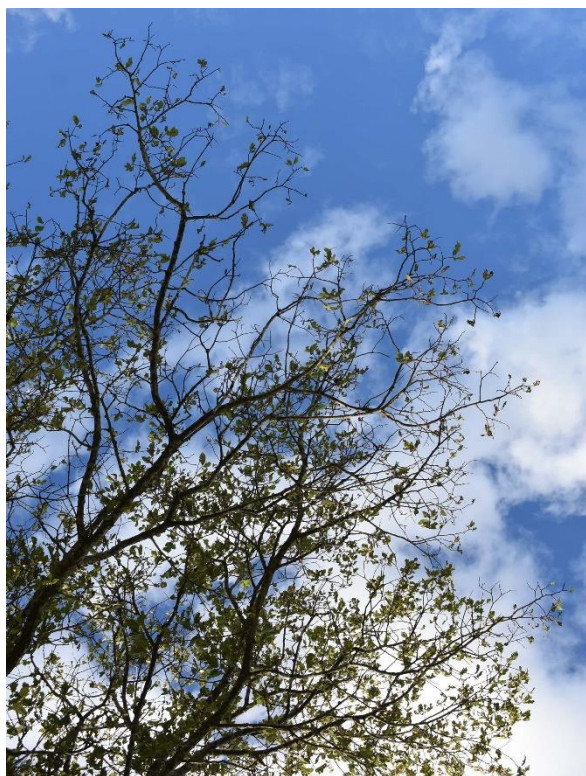
Figure 24: Defoliation may be a combination of insect and possum grazing

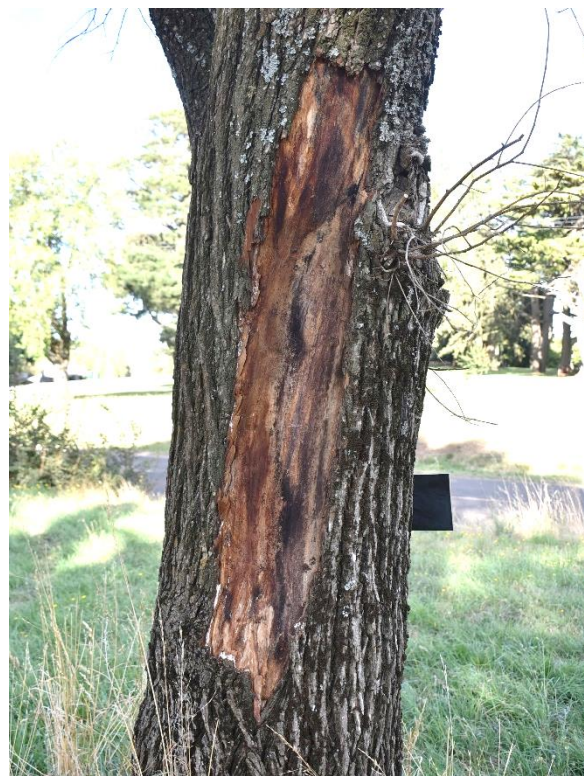
Figure 25: Bark was removed from dead tree E50 – no signs of Elm bark beetle visible

- Seven trees are recommended for High priority works.
  - Trees E11 (young), E50 (mature), and W13 (young) are dead or near dead and are recommended for removal and replacement within the next 12 months.

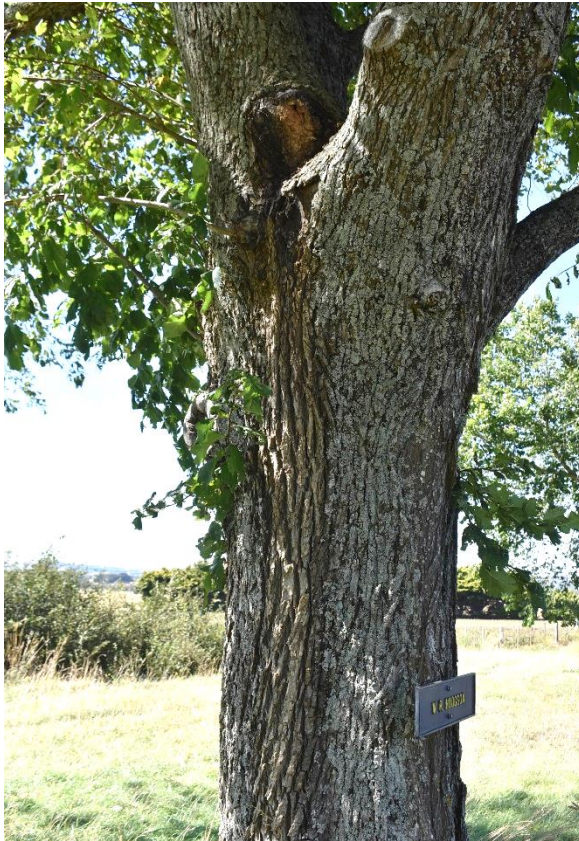
Figure 26: Wetwood in the union of a mature tree, with staining down the trunk

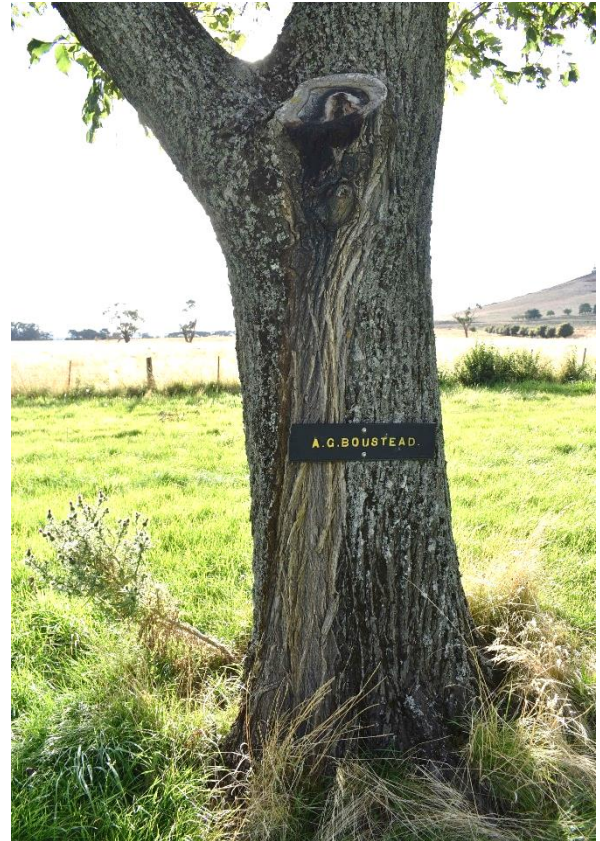
Figure 27: Dried wetwood from an old pruning wound, with staining down the trunk

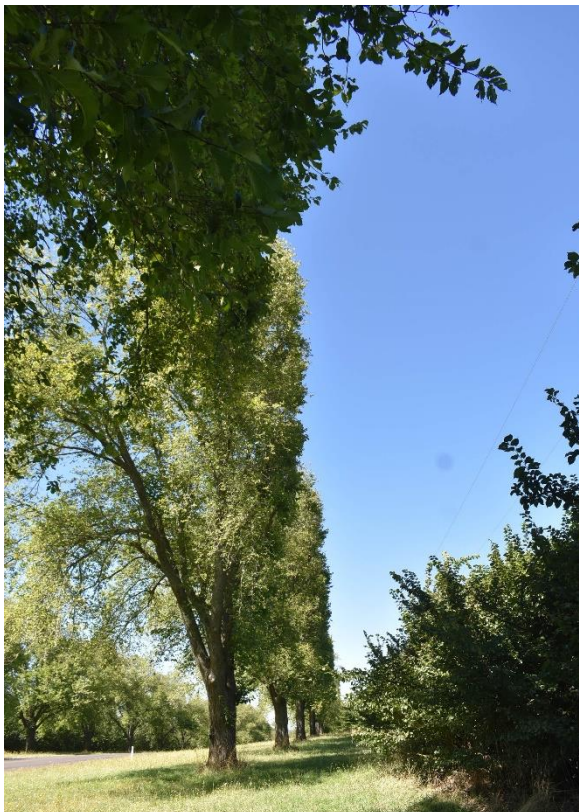
The powerline clearance pruning has altered the natural tree form in many cases, resulting in an asymmetrical canopy and vigorous epicormic growth, requiring regular removal to maintain clearances. Trees expend significant energy producing this flush of growth, to the detriment of other biological processes and continued removal of branches for powerline clearing has the potential to impact mature trees with lower energy reserves.

Figure 28: Powerline clearance pruning on the western side of the Avenue
