# **Tree Management Plan**

## **the Kingston Avenue of Honour**

**Homewood Consulting Pty Ltd**  
Unit 10 / 350 Settlement Road  
Thomastown VIC 3074

**Tuesday, 1 March 2022**

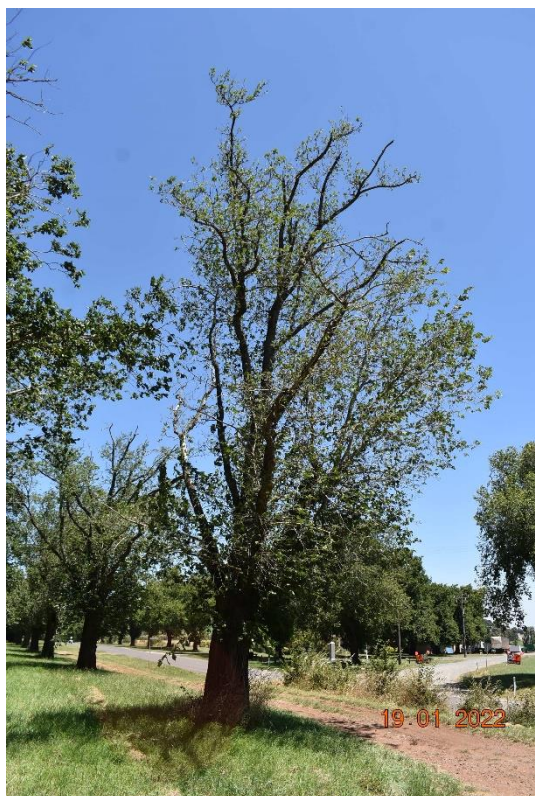
10% of the trees have Poor health, 2% have Very poor health and 1% (two trees) are dead. Indicators of inferior health included a thinning or sparse canopy, usually with insect and/or mammal defoliation, and significant deadwood in the canopy.

Figure 2: Canopy density, leaf size and deadwood are indicators of tree health

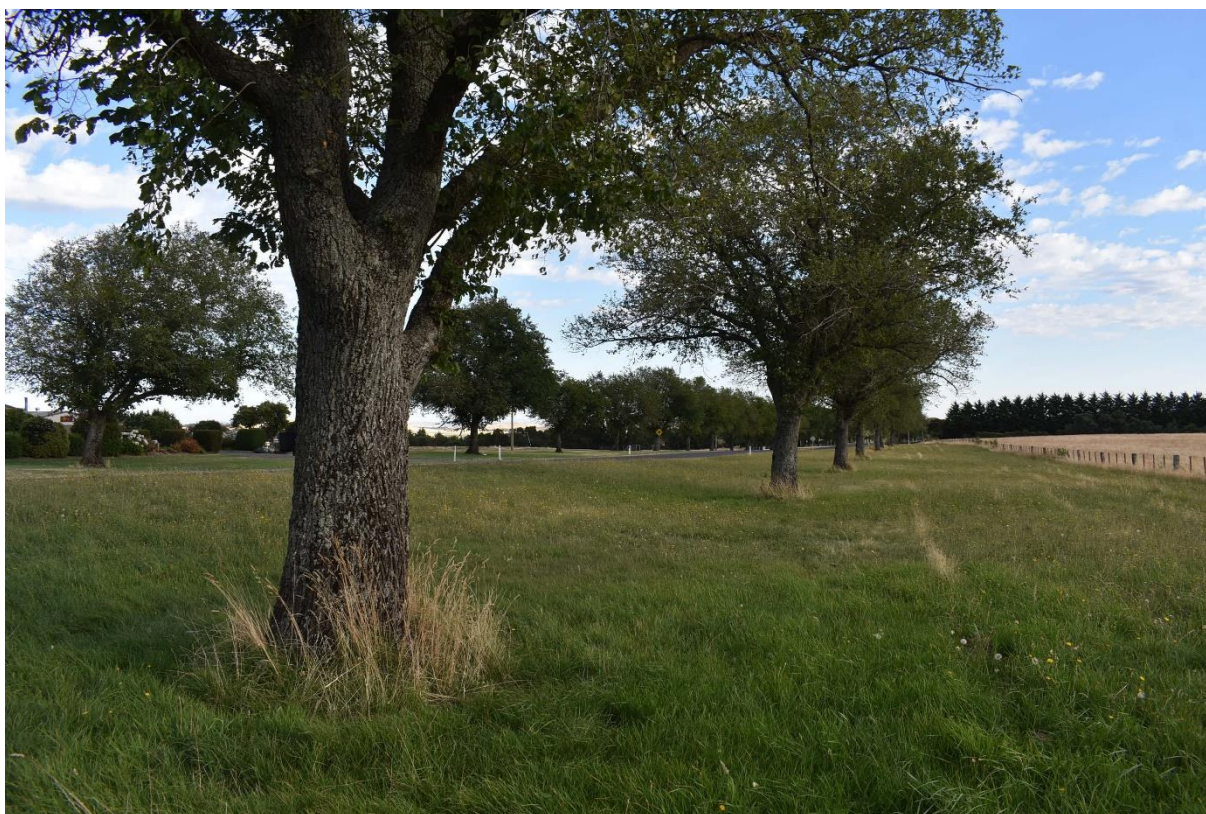
The wide verge in which the Avenue trees are planted, the significant setback from the road (for the majority of trees), and the virtual absence of pedestrian movement along this section of road means that most of the trees have a very low target occupancy, and subsequently represent a very low risk of harm to people and property. That is, even a tree with a high probability of failure of a large branch will not, in most instances, pose a substantial risk as the branch is very unlikely to hit any target of value.

Figure 17: The trees are planted in a wide road verge and the majority are set back from the road. There are no pedestrian paths on the verge.

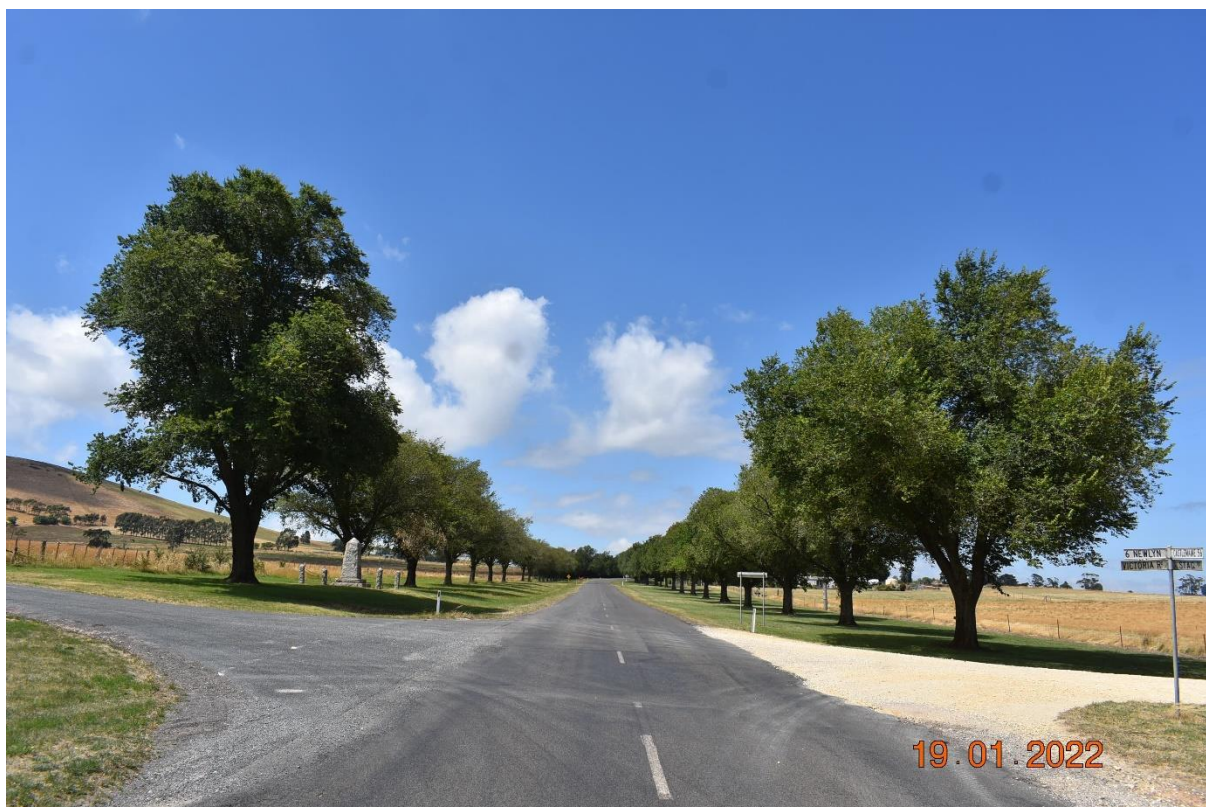
Overall, the Kingston Avenue of Honour is in fair condition.

Figure 23: The Avenue is in Fair condition overall, and is largely intact as a landscape unit

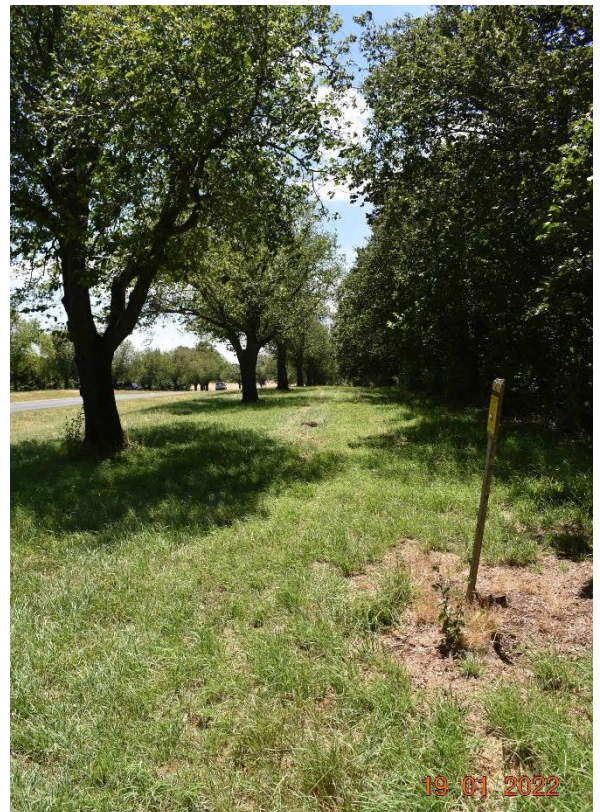
Figure 29: Sign indicating underground cables on the eastern side of the Avenue

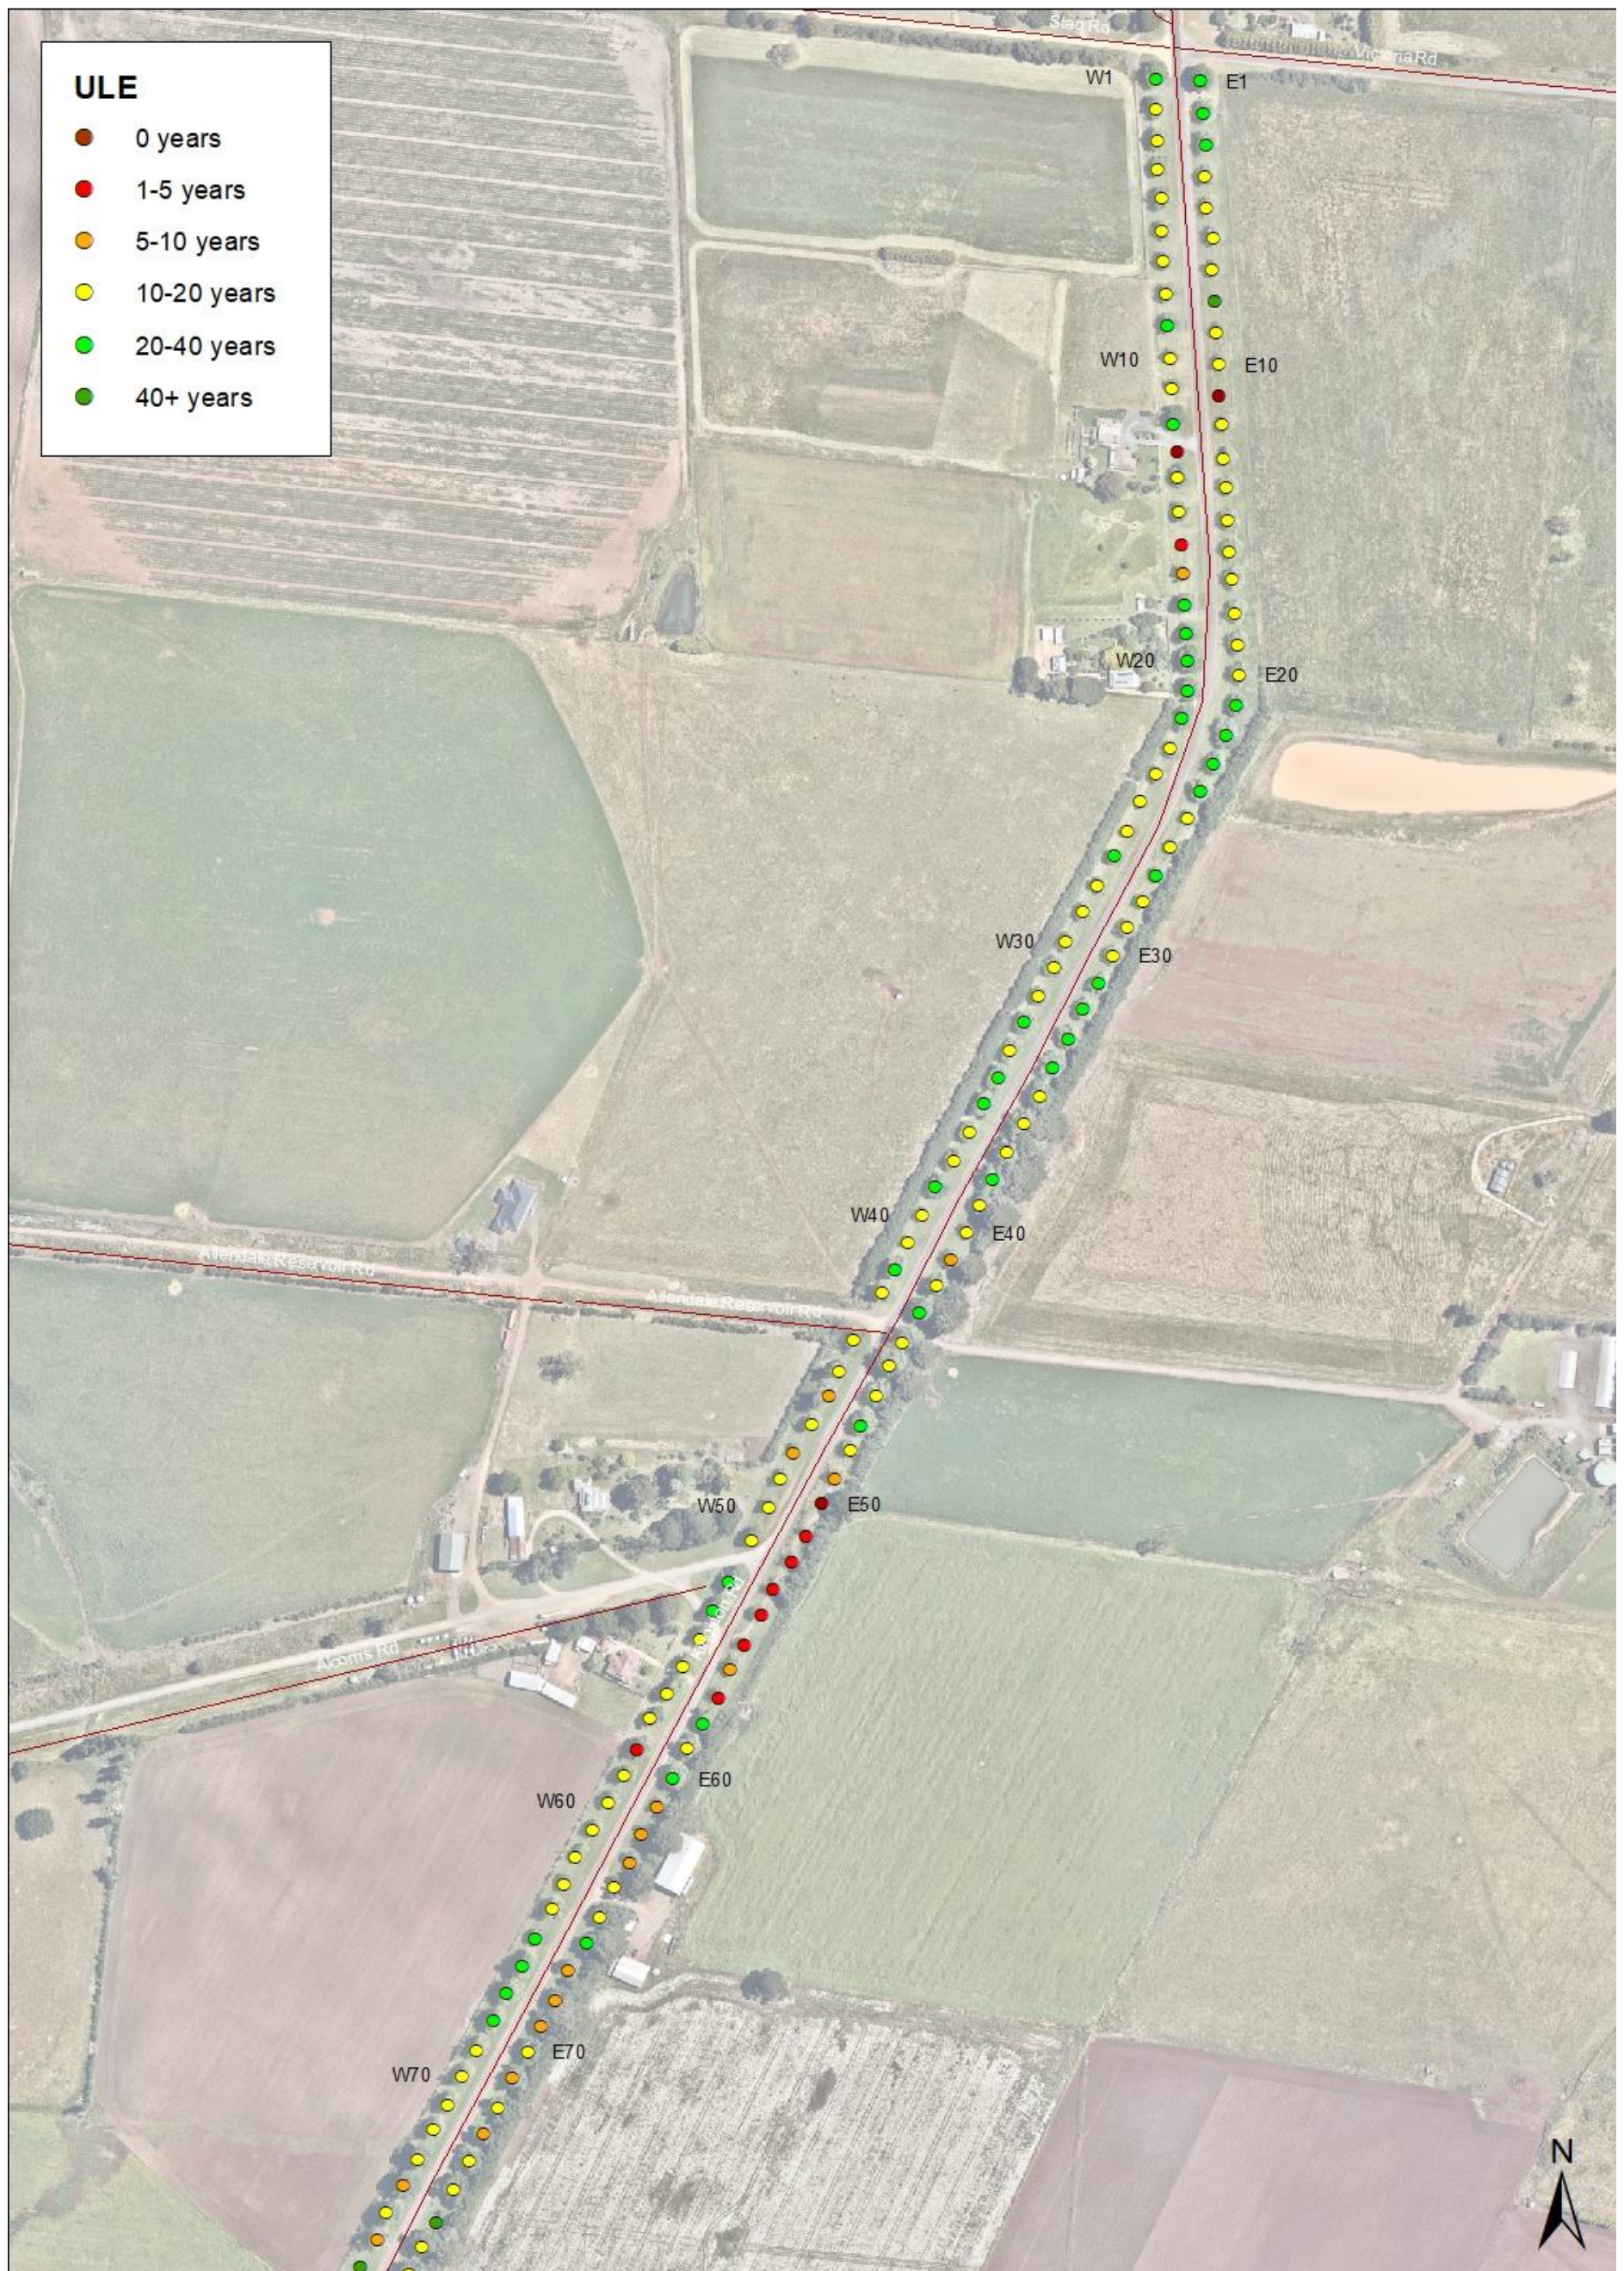
Plans depicting the Useful Life Expectancy of the Kingston Avenue of Honour trees are shown in Figure 30 and Figure 31. These maps are a visual representation of the overall condition of the trees and depict trees recommended for removal in the short term (ULE <5 years) and the life expectancy of the trees to be retained.

Figure 30: Useful Life Expectancy Plan for the northern half of the Avenue of Honour – Trees W1/E1 to W77/E78

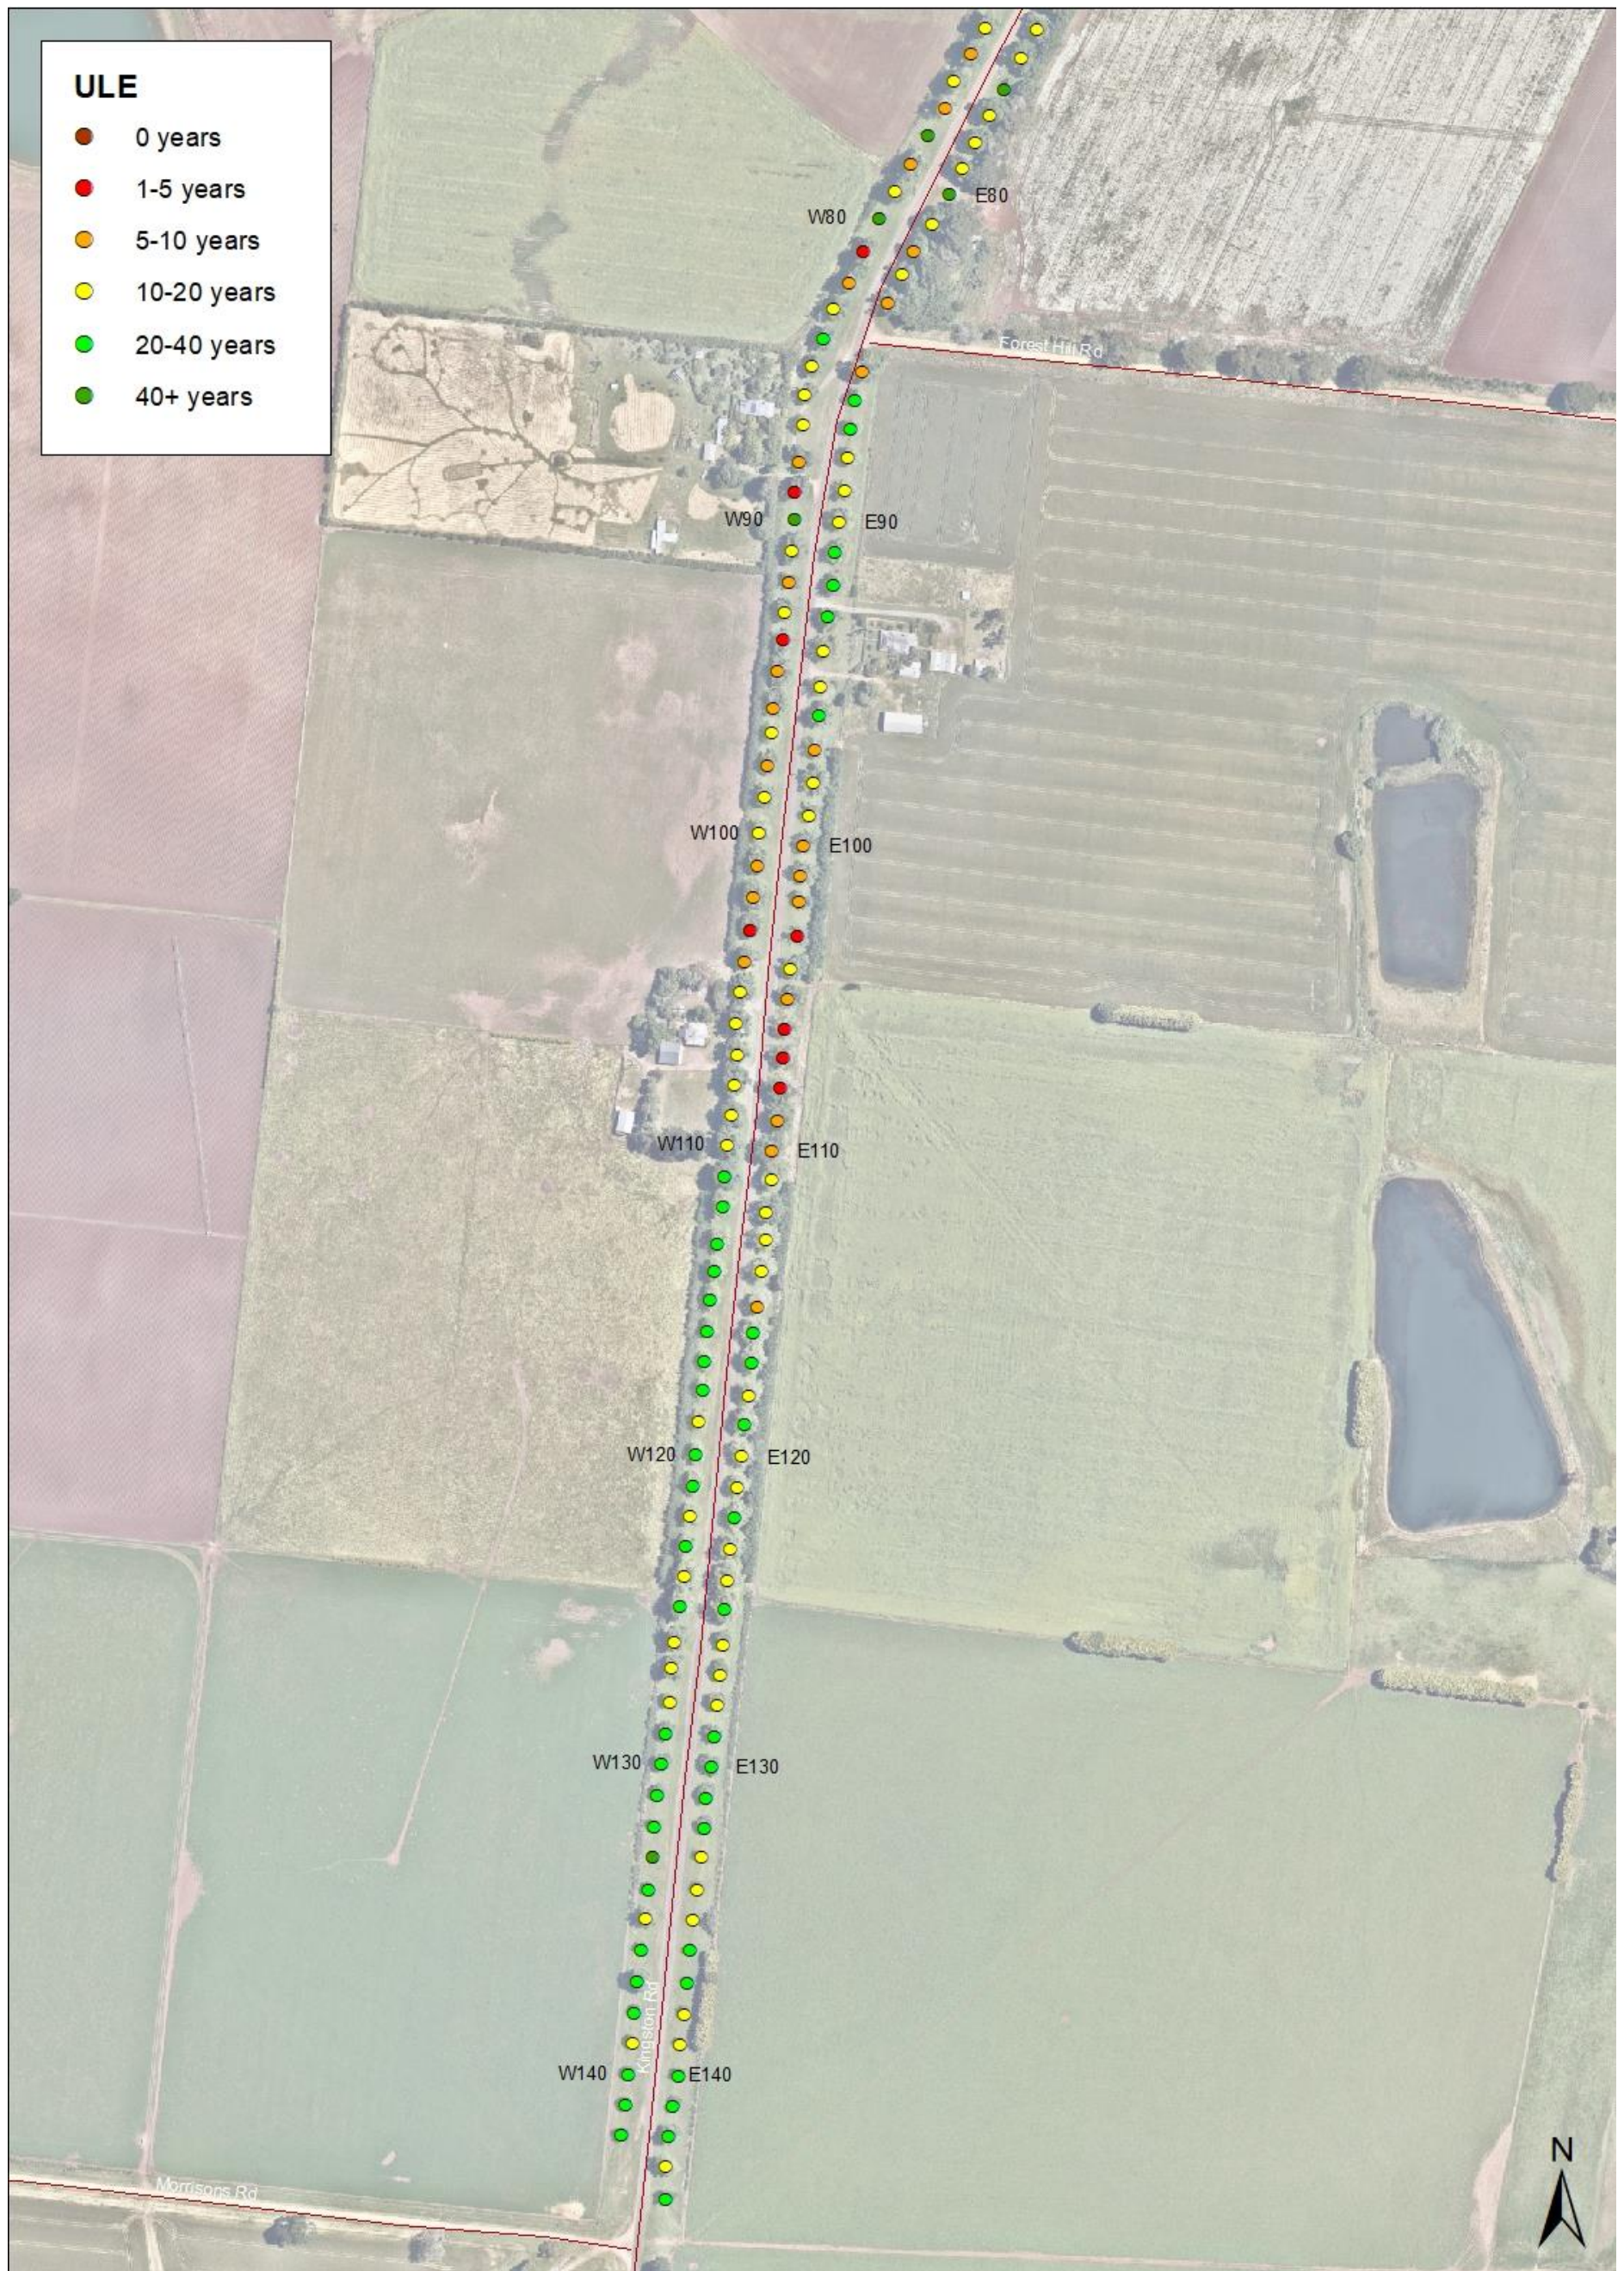
Figure 31: Useful Life Expectancy Plan for the southern half of the Avenue of Honour – Trees W73/E74 to W142/E144
